Analysis of the Ground Sinking around an Excavation Site using GPR Exploration

Yushik Han¹ and Ki-Cheong Yoo²

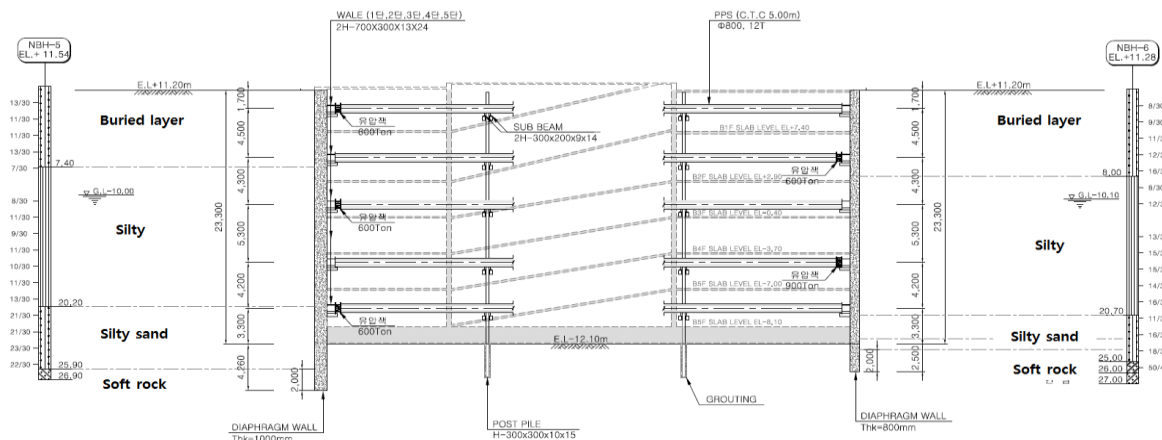
As for the ground condition of the excavation site in the OO area (Fig. 2), the buried layer located between the ground surface and a depth of 7.5m consists of loose sand and gravel mixed with silt, and it has an average N value of about 6. Beneath the aforementioned layer, silty sand (SM) is distributed down to 22.5m. It is a very solid layer with an average N value of about 15. Then, very dense gravelly sand with an average N value of more than 30 is distributed down to 25.0m, and soft rock is distributed beneath the gravelly

sand. In addition, the groundwater level is located 10.0m below the ground surface.

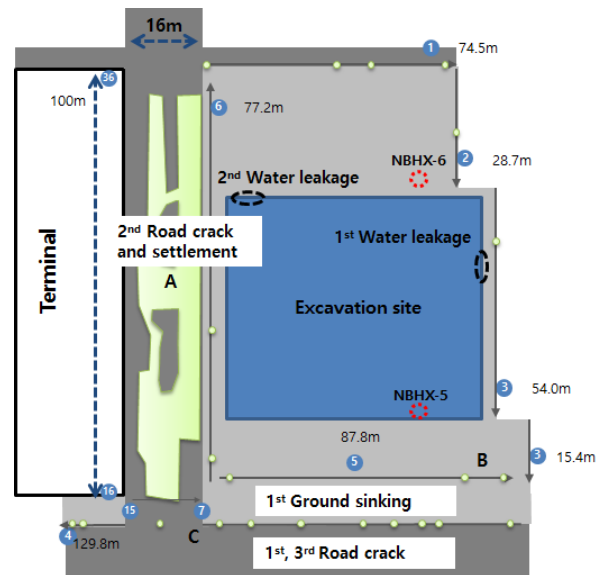
Fig. 3: Outline of the ground sinking in the OO area of Korea

In the case of the initial ground sinking and road crack, groundwater was discharged from the first water leak joint position of the diaphragm wall that is 20m below the ground surface (Fig. 3) at around 2:40 p.m., February 6, 2017, and the groundwater level decreased by 1.0m. In the first ground sinking occurrence region (Fig. 3), ground sinking 3m in length and 30cm in depth took place and a crack 30m in length and 0.05~0.1m wide was formed (Fig. 4(a)).

In the case of the second road crack and settlement event, groundwater was discharged from the second water leak joint position of the diaphragm wall that is about 20m below the ground surface (Fig. 3) at around 6:30 p.m., February 14, 2017 during the reinforcement work in relation to the first accident, and the groundwater level decreased by about 6.0m. In the second ground settlement occurrence region (Fig. 3), a road crack and settlement that was 100m in length were formed (Fig. 4(b)).

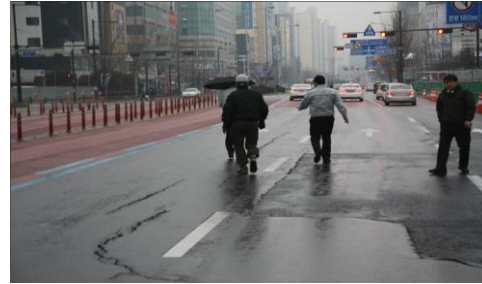
(d) Third road crack

In the case of the third road crack event, a crack that was 20m in length and 0.03~0.05m wide was formed in the same region where the initial ground sinking event occurred, at around 3:20 p.m., February 22, 2017 (Fig. 4(c)).

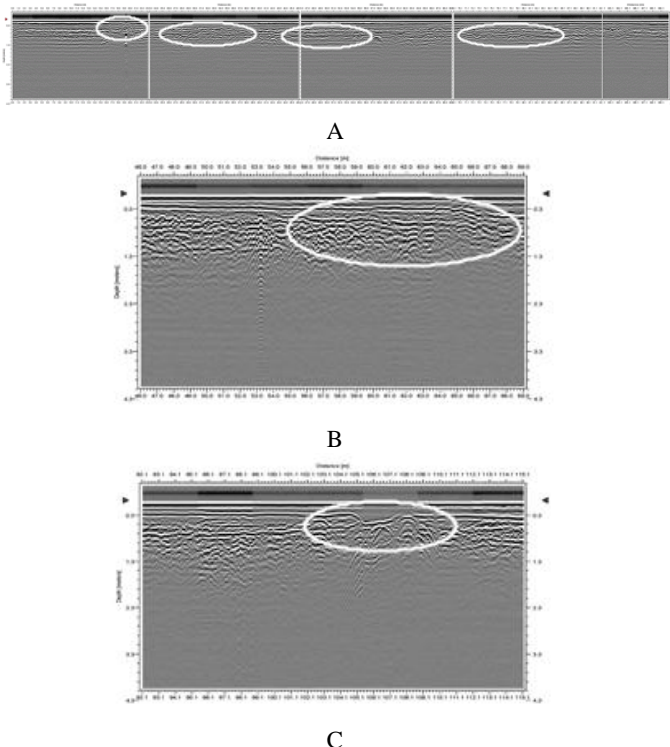
Fig. 5: GPR Exploration Result

The surrounding region of the excavation site in Fig. 3 was examined using GPR exploration equipment (Mala 450MHz) on February 21, 2017, and the result showed that the surrounding ground of the excavation site was loosened. In particular, the ground loosening region was widely distributed underneath the road of the second ground settlement occurrence region (Fig. 5).

2. Ground loosening occurred in the surrounding ground of the excavation site due to the groundwater discharge at the excavation site, and the ground loosening region was widely distributed over the surrounding ground with a groundwater level of more than 6.0m.
