Analysis of the Ground Sinking around an Excavation Site using GPR Exploration

Abstract: A sinkhole can be formed due to a number of causes. In particular, artificially induced sinkholes that are frequently observed in Korea have been classified into different types. In this study, a sinkhole induced by groundwater level disturbance in an excavation site was analyzed, and the ground loosening region around the excavation site was also analyzed based on GPR (Ground Penetrating Radar) exploration. Due to groundwater discharge in the excavation site, ground loosening occurred in the surrounding ground area of the excavation site, and the ground loosening region was widely distributed over the surrounding ground with a groundwater level of more than 6.0 m.

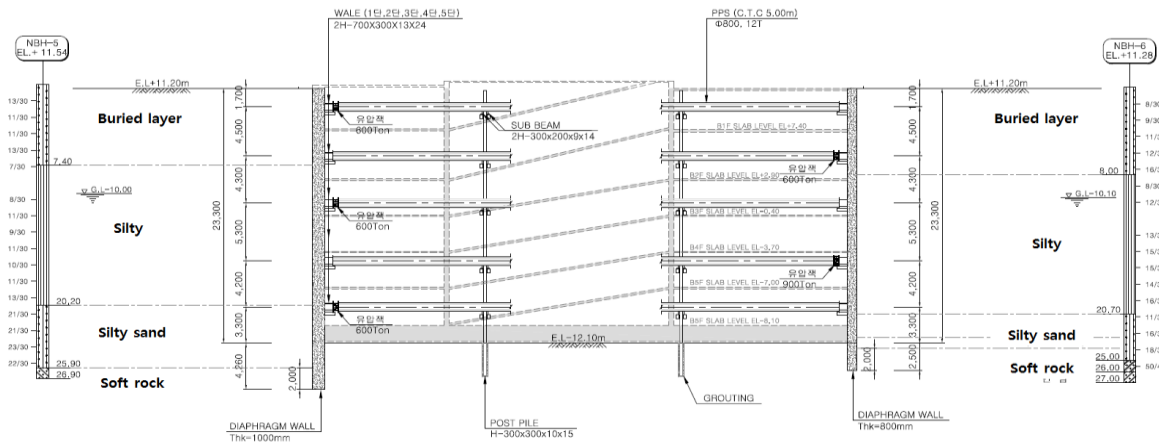
Fig. 2: Sectional view of the excavation plan

As for the ground condition of the excavation site in the OO area (Fig. 2), the buried layer located between the ground surface and a depth of 7.5m consists of loose sand and gravel mixed with silt, and it has an average N value of about 6. Beneath the aforementioned layer, silty sand (SM) is distributed down to 22.5m. It is a very solid layer with an average N value of about 15. Then, very dense gravelly sand with an average N value of more than 30 is distributed down to 25.0m, and soft rock is distributed beneath the gravelly sand. In addition, the groundwater level is located 10.0m below the ground surface.

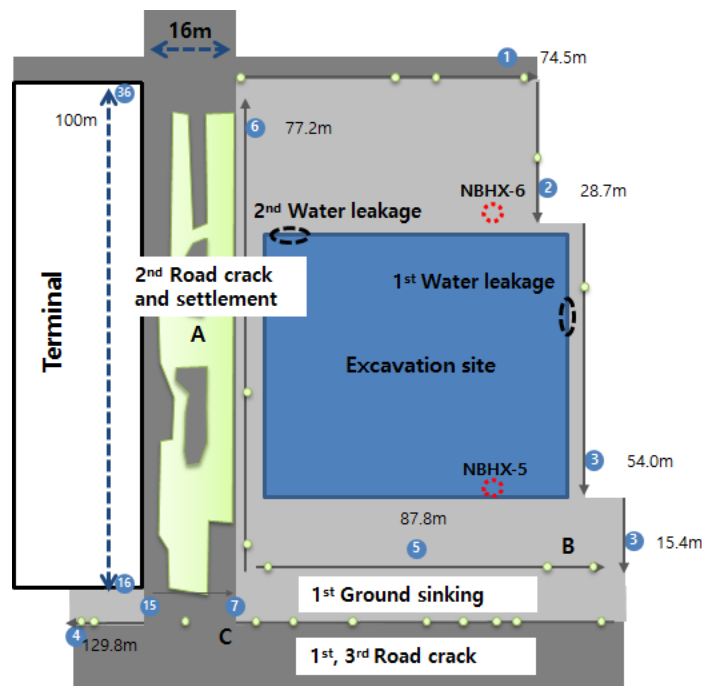
Fig. 3: Outline of the ground sinking in the OO area of Korea

In the case of the initial ground sinking and road crack, groundwater was discharged from the first water leak joint position of the diaphragm wall that is 20m below the ground surface (Fig. 3) at around 2:40 p.m., February 6, 2017, and the groundwater level decreased by 1.0m. In the first ground sinking occurrence region (Fig. 3), ground sinking 3m in length and 30cm in depth took place and a crack 30m in length and 0.05~0.1m wide was formed (Fig. 4(a)).

In the case of the second road crack and settlement event, groundwater was discharged from the second water leak joint position of the diaphragm wall that is about 20m below the ground surface (Fig. 3) at around 6:30 p.m., February 14, 2017 during the reinforcement work in relation to the first accident, and the groundwater level decreased by about 6.0m. In the second ground settlement occurrence region (Fig. 3), a road crack and settlement that was 100m in length were formed (Fig. 4(b)).

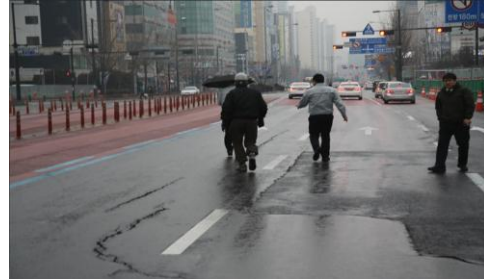
(d) Third road crack

In the case of the third road crack event, a crack that was 20m in length and 0.03~0.05m wide was formed in the same region where the initial ground sinking event occurred, at around 3:20 p.m., February 22, 2017 (Fig. 4(c)).

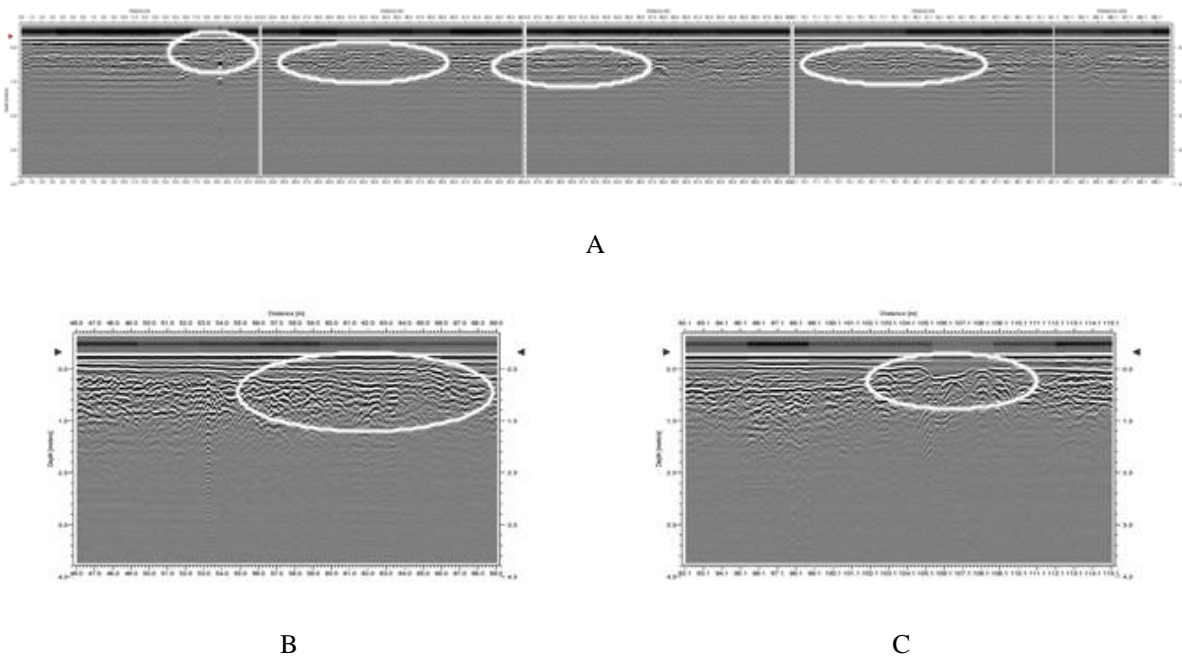
Fig. 5: GPR Exploration Result

The surrounding region of the excavation site in Fig. 3 was examined using GPR exploration equipment (Mala 450MHz) on February 21, 2017, and the result showed that the surrounding ground of the excavation site was loosened. In particular, the ground loosening region was widely distributed underneath the road of the second ground settlement occurrence region (Fig. 5).

2. Ground loosening occurred in the surrounding ground of the excavation site due to the groundwater discharge at the excavation site, and the ground loosening region was widely distributed over the surrounding ground with a groundwater level of more than 6.0m.
