Evaluation of Coating Degradation on Truss of Maubin Bridge, Myanmar

Khin Khin Thaw

Abstract—Paper presents the existing coating deterioration on truss of Maubin Bridge, Ayeyarwady Region, Myanmar. The purpose of this study is to conduct a preliminary assessment of the bridge truss coating for pilot repainting. The assessment includes evaluation of degradation of coating, cross-cut test and measuring coating thickness. According to evaluation of degradation of coating, maximum degree of rusting is Ri 3 and the maximum degree of flaking is flaking without preferential direction (panels of area 1dm^2 to 2dm^2): Quantity (density) 3. And then, cross-cut test results showed classification 5 for outer face of outside flange and classification 3 for outer face of inside flange of truss diagonal member. The existing coating thickness is in the range of $160\mu\text{m}$ - $450\mu\text{m}$ for all diagonals of truss.

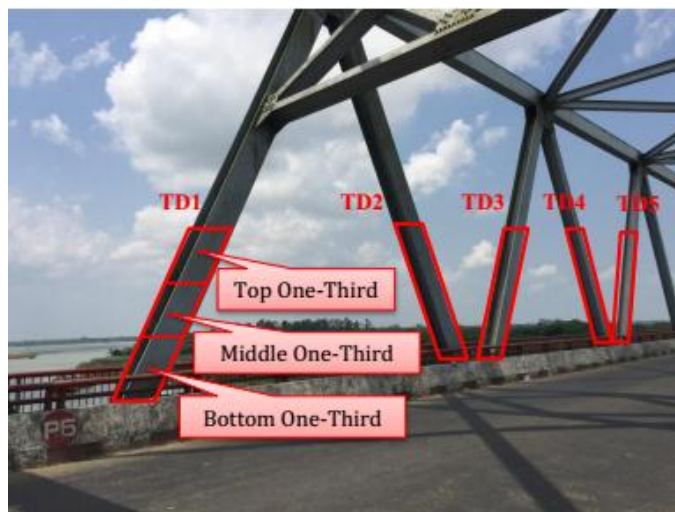
Fig. 3 Coating thickness measured area in test regions

Coating thicknesses were measured more detailed in test region by dividing measured 1m length into three portions. There were measured 5 points on each portion of the faces. The comparison of coating thickness for test diagonals (TD1-TD5) are shown in Fig. 4, Fig. 5, and Fig. 6.

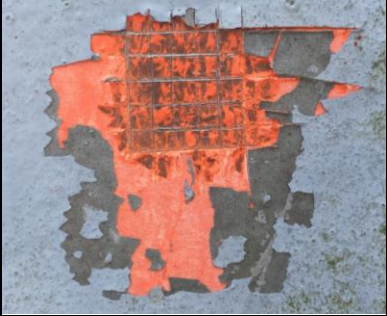
Diagonal No.	Test Face	Appearance of surface of cross-cut area	Classification
TD4	A

5
	D

- 1) For Face A, the result showed Classification 5 and all three layers do not work well. The primer layer do not adhesive on substrate so all layers should be removed out for repainting.
- 2) The result described Classification 3 for Face D. In this case, top coat and intermediate coat do not perform well definitely and primer layer does not work probably about 35%. Therefore, all layers should be also removed out for repainting.

According to evaluation results, the truss of Maubin Bridge should be repainted. In this case, all three layers should be removed because there is no adhesion between top coat intermediate coat and primer, and less adhesion between primer and substrate. The new anticorrosive coating system which is long-lasting and economical should be selected before actual repainting.

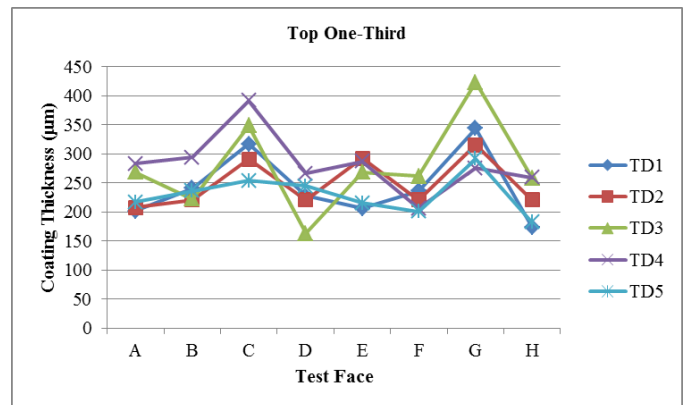
Fig. 4 Coating thickness comparison for top one-third of test diagonals

For top one-third, the minimum coating thickness is 173µm on TD1-Face H and the maximum coating thickness is 423µm on TD3-Face G.

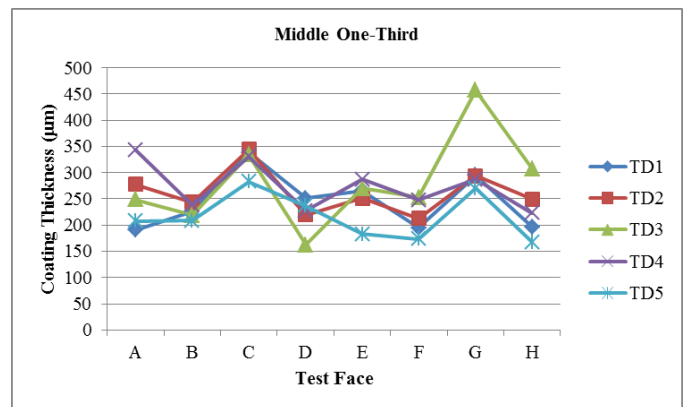
Fig. 5 Coating thickness comparison for middle one-third of test diagonals

The minimum coating thickness is 162µm on TD3-Face D and the maximum coating thickness is 456µm on TD3-Face G for middle one-third.

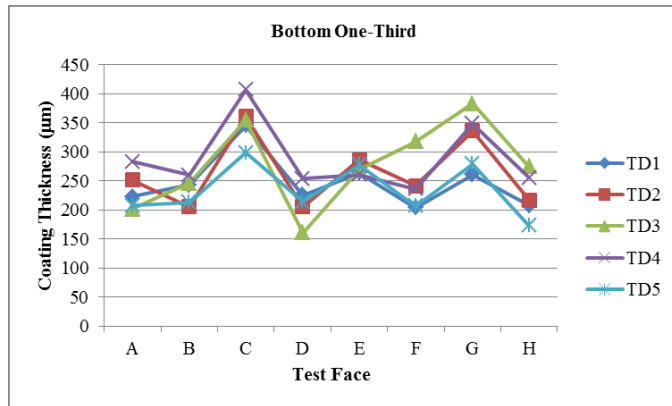
Fig. 6 Coating thickness comparison for bottom one-third of test diagonals

For bottom one-third, the minimum coating thickness is 160µm on TD3-Face D and the maximum coating thickness is 406µm on TD4-Face C.

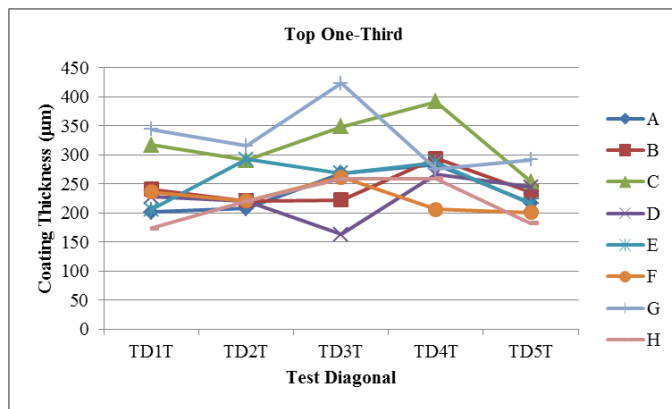
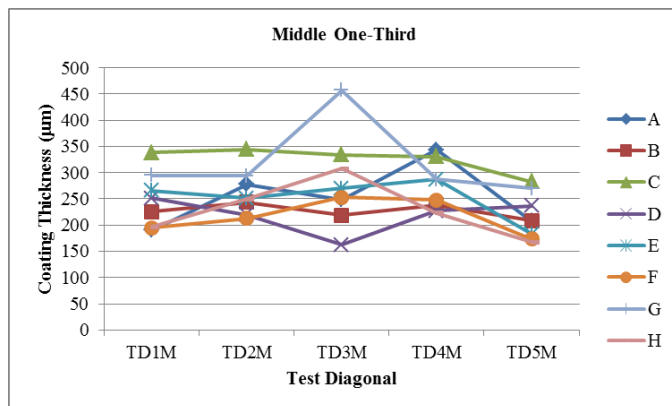
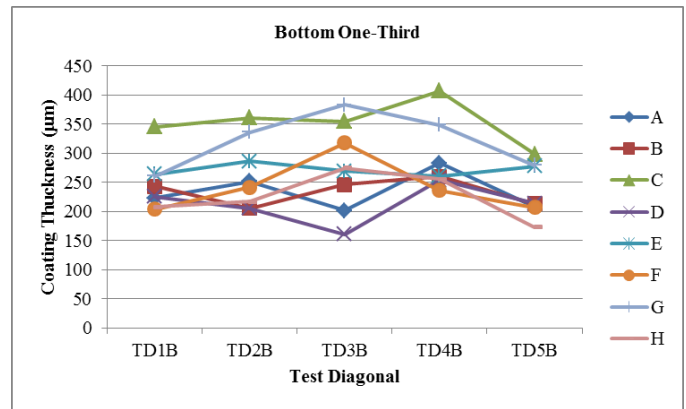
In coating thickness comparison for faces of test diagonals, the minimum coating thickness is 160µm on TD3-Face D and the maximum coating thickness is 456µm on TD3-Face G. According to the investigation results in test region, coating thicknesses are the same for the faces along each diagonal.

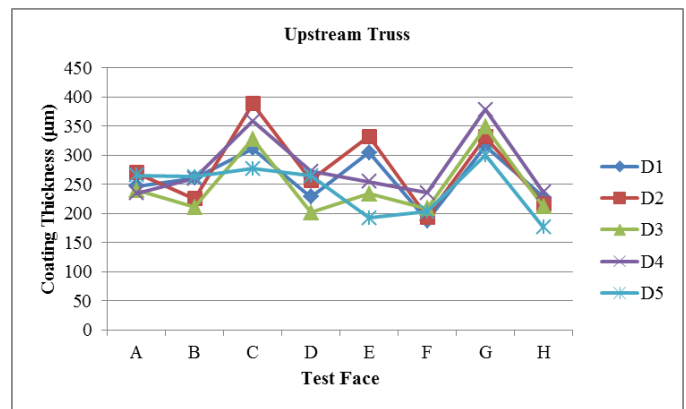
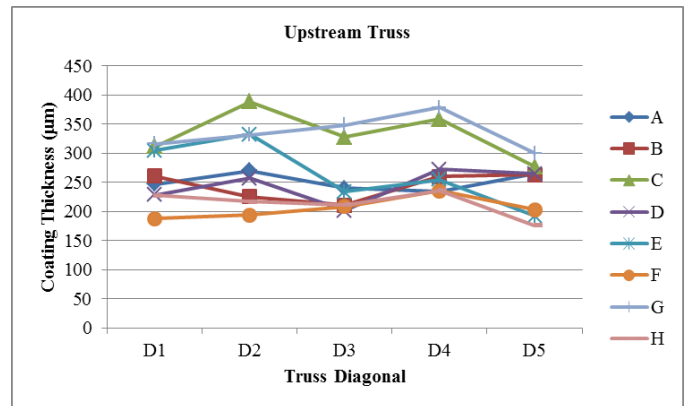
For upstream truss diagonals, the minimum coating thickness is 176µm on D5-Face H and the maximum coating thickness is 388µm on D2-Face C.

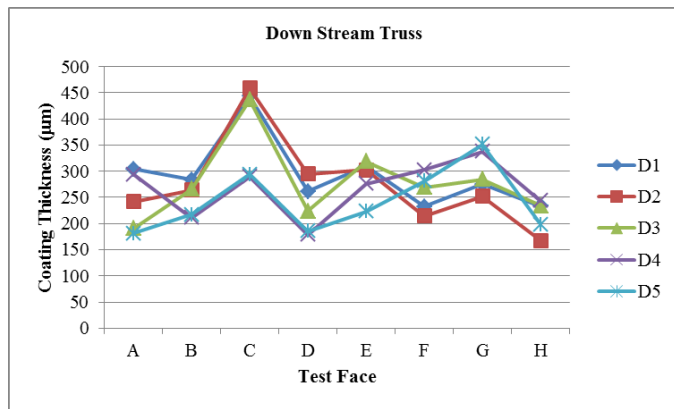
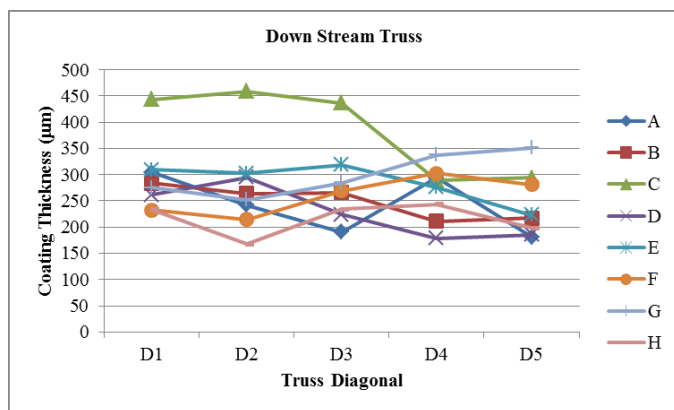
For downstream truss diagonals, the minimum coating thickness is 167µm on D2-Face H and the maximum coating thickness is 458µm on D2-Face C.

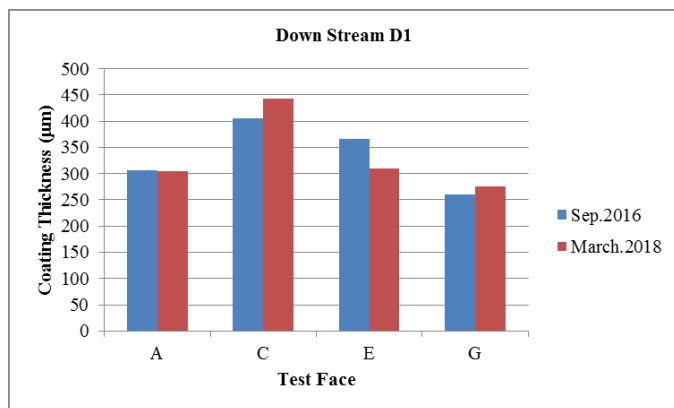
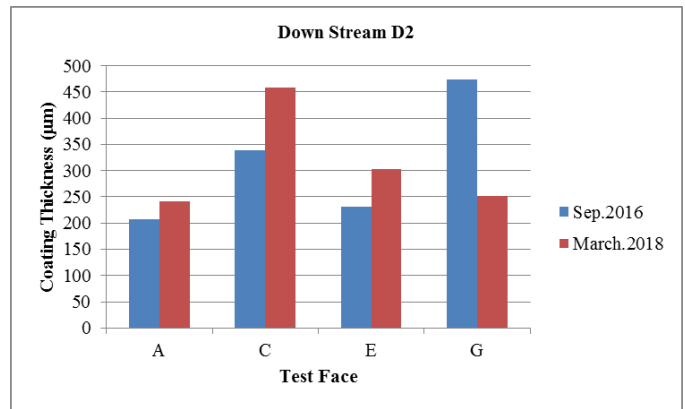
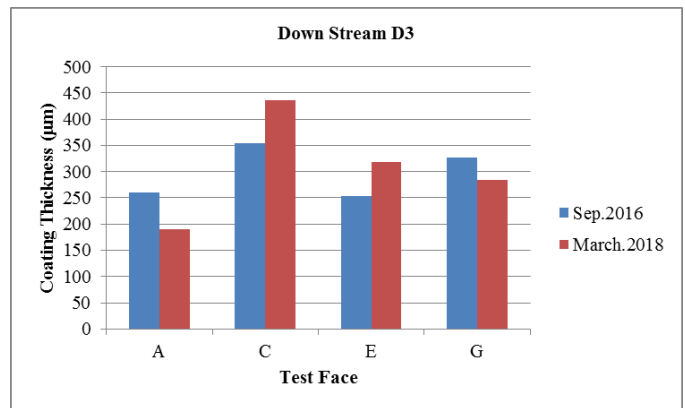
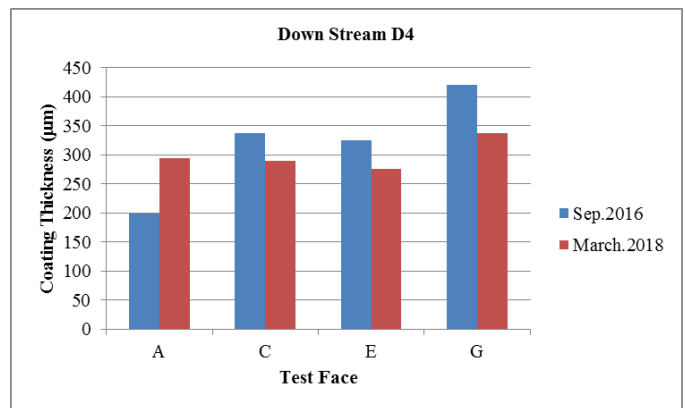
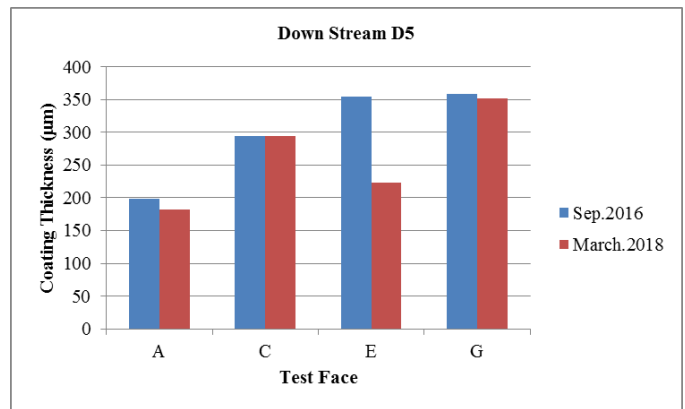
- 1) The coating thickness has risen about $14\mu\text{m}$ - $120\mu\text{m}$ for web and $34\mu\text{m}$ - $95\mu\text{m}$ for flange.
- 2) For web, the coating thickness has reduced in the range of $0.4\mu\text{m}$ - $222\mu\text{m}$ and $1.6\mu\text{m}$ - $131\mu\text{m}$ in thickness reduction for flange.
