Issues Affecting Water Distribution Systems

Abstract— Mauritius receives enough rainfall (over 2000 mm/year) to cater for the national demand. However, Mauritians face problems of water stress, especially during periods of low rainfall. This study investigates the technical problems in the water distribution system and discusses on the means to solve these problems and improve the system.

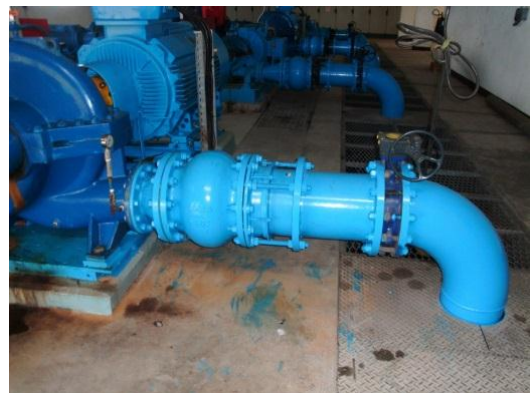
Three main water distribution plants and their related pipeline circuit in Mauritius were studied in order to identify the main problems. The main components of the water distribution systems which were considered are the pumps in the distribution plants and pipeline circuits. One of the plants considered for investigation is shown in fig. 1.

Fig. 1- One of the plants considered for investigation

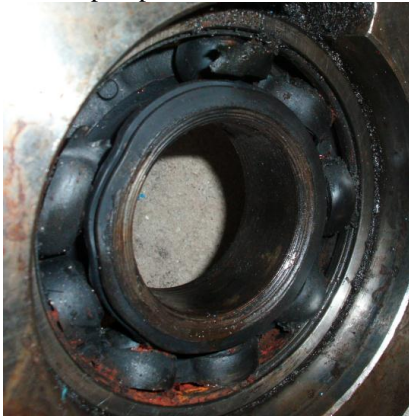
Fig. 2- Corroded and damaged bearing

Bushings and wear rings are expected to wear out and thus protect other components. Bearings and mechanical seals, on the other hand, can lead to serious problems, especially to more critical components such as the shaft and the motor. In fact, the actual lifetime of the bearings were found to be a third of their expected lifetime.

Since bearings and bushings are a major problem in the pumps, alignment of the pumps and motor should be performed accurately. It should be noted that presently this is performed very rapidly using rulers, as shown in fig. 8.

Also, preventive or predictive maintenance should be performed on the pumps, especially in relation to the bearings and the bushings. Predictive maintenance could involve vibration analysis. Preventive maintenance could involve routine checks, quarterly and annual checks. Adjustable Speed Drives could be used on the pumps which were not used efficiently. For the cavitation problems, since ceramic coating of the impellers have not proved effective, other methods should be envisaged.

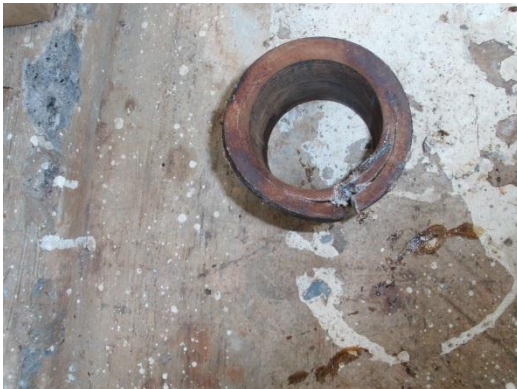
Fig. 3- Worn out bushing

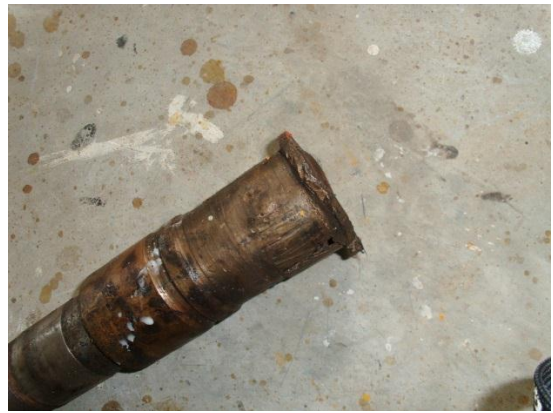
Fig. 4- Failed shaft

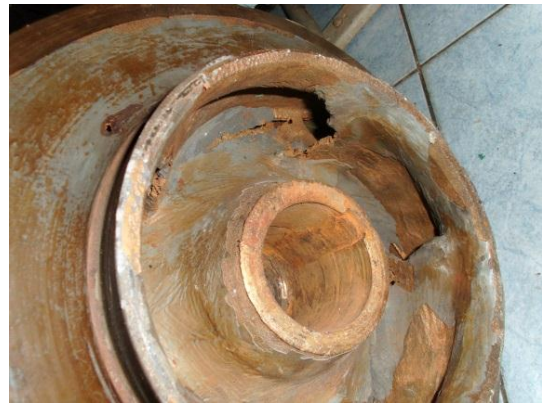
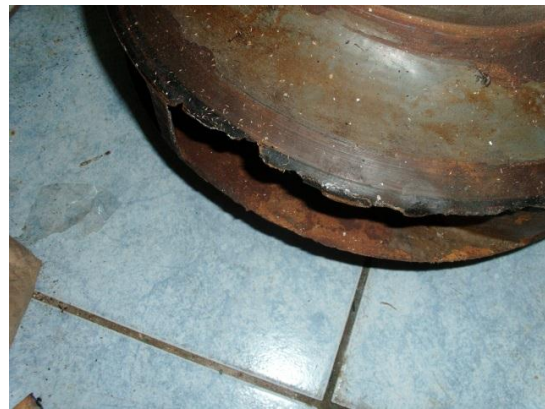
This problem occurs quite frequently in Mauritius. This can lead to the damage of impeller of the pump, as shown in fig. 7 (a) and (b).

Fig. 7(a) – Damaged impeller due to cavitation

Fig. 7(b)- Damaged impeller due to cavitation

It was observed that pumps which were frequently damaged by cavitation had the available Net Positive Suction Head less than the required Net Positive Suction Head for much of their operating time.

To solve this problem of cavitation, the supply tank would either have to be raised or the pump level would have to be decreased so as to eliminate cavitation. In both cases it would be practically impossible. Hence, the solution to this problem would be to use impellers which are more resistant to cavitation. Materials such as 316 stainless steels or 6082 Al Alloys would resist cavitation better than contemporary impeller material like bronze and cast iron [6,7]. Nitriding of low alloy steel impellers have also demonstrated significant resistance to cavitation [8,9]. Use of ceramic coatings are also considered as a solution to protect the impeller against cavitation and increase the hydraulic efficiency of the pump as well [10]. It should be noted that this solution was implemented to reduce the problem of cavitation. However, it was not effective.

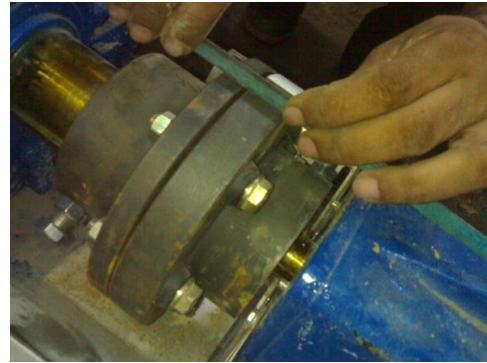
Fig. 8- Alignment of pump and motor
