Conserving Energy Using Heritage Systems for Renovated Heritage Houses to Museums at Sharjah City.

Abstract: This paper presents several strategies to control day light at Bait Obaid Al-Shamesi and Emirate Fine Arts Society (Annual Photography Exhibition) where both are originally heritage buildings located at Sharjah in UAE and were renovated to museums. This study is a comparison between the methods of natural lighting used in both museums before and after renovation. The lighting results were evaluated using both manual and computer-assisted ways, the manual way to assess the light using Lutron Light Meter (LM-8000A) Anemometer, and the computer-assisted way was using REVIT Architecture software with Lighting Analysis Plugin. The manual readings were during day-hour time with all artificial lights on, however, software analysis was during day-hour time with all doors shut and the artificial lights were completely “off”.

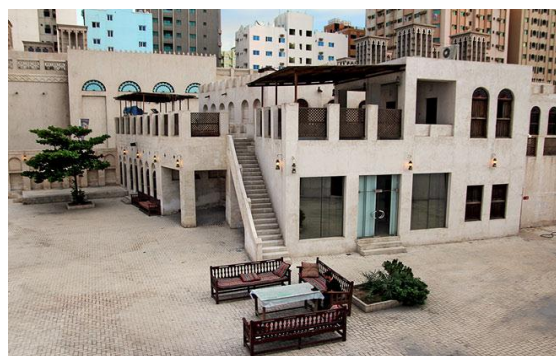
Bait Obaid Al Shamesi (Fig.1) was owned by the late Obaid Bin Esa Al Shamsi and built around the year 1845. The Building reflects Arabic-Islamic Architecture and simulate the absolute spirit of Sharjah in a two-story house. The house contains 16 rooms, three of which are at the upper floor. There are also parlours, extensions and stairs, as well as the distinctive top ventilation-structures wind-towers “Barjeel”. After the 1997 renovation, 13 studios came up around the traditional courtyard, which are rented to professional artists to practice their work constantly.

Fig.1: Bait Obaid Al-Shamesi museum. [1]

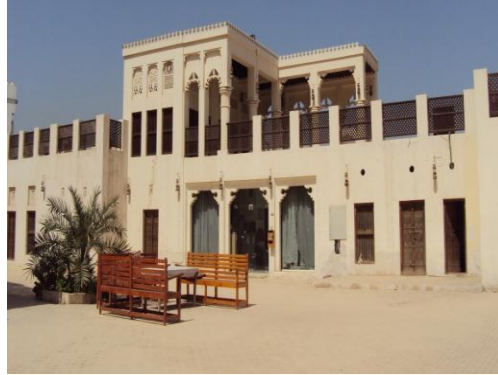
The site visit took place in 12th April 2016 at 12:00 p.m. the date and time were chosen to be in spring were the weather at the U.A.E is average. When entering Bait Obaid Al-Shamesi Museum at Sharjah you will enter a small room that leads to a huge courtyard (Fig.10). The ground floor contains multi closed unused rooms rather than the offices, no exhibitions exist at this floor.

Fig.10: Bait Obaid Al-Shamesi Museum view from the courtyard (Source: Author, 2016).

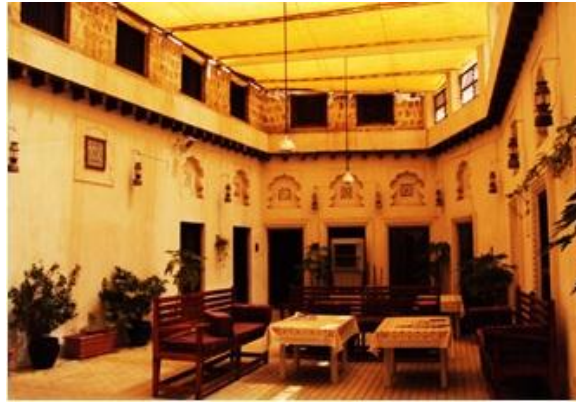
Fig.13: Emirate Fine Arts Society's yellowish courtyard. (Source: Author, 2016).

On the other hand, when entering the Emirate Fine Arts Society (Annual Photography Exhibition) The media room will be directly to the right side, which is a closed room with very tiny windows to meet the needs of darkness for projectors presenting. The courtyard is to be at the left side and it is shaded -unlike Bait Al-Shamesi Museum's courtyard- however, the shading device is so yellowish (Fig.13), though it solves the problem of direct sun-light but it is still affecting the aesthetic of space and doesn't feel comfortable when entering the courtyard.

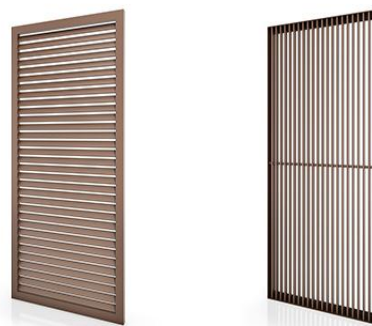
Fig.19: Wooden Louver Example. [3]

The Emirate Fine Arts Society Museum solution is shown at (Fig.18), where the Annual Photography exhibition is finally merged with light, and the courtyard's fabric shading device is replaced with the wooden louvers (Fig.19).

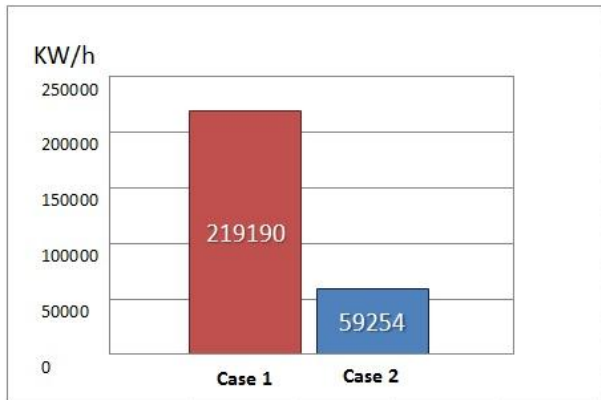
Chart.1: Output comparison between the annual energy use/cost before and after solution for Bait Obaid Al-Shamesi Museum. Using Revit Architecture 2014 software, Energy Analysis Plugin. (Source: Author, 2016).

The second goal of this paper was achieved after applying solutions to both cases, which was reducing energy consuming at the museums. As shown in (Chart.1) for the Shamesi Museum where (Case 1) represents the existing case and (Case 2) represents the case after solution where the building used to consume 94%, and after treatment it decreased to 44%. The same goal was achieved with the Emirate Fine Arts Society Museum shown on (Chart.2) where (Case 1) represents the existing case and (Case 2) represents the same case after solution, where the building used to consume 96% and after treatment it decreased to 25%.
