Corrosion of Aircrafts - A Case Study in Mauritius

Kunal Boodhun, and B.Y.R. Surnam

Abstract—Corrosion is actually one of the main problems in aircrafts. In Mauritius, the international airport at Plaisance is situated at 250m from the shoreline and has a relative humidity level frequently above 85%. These factors would inevitably increase the amount of corrosion in aircrafts.

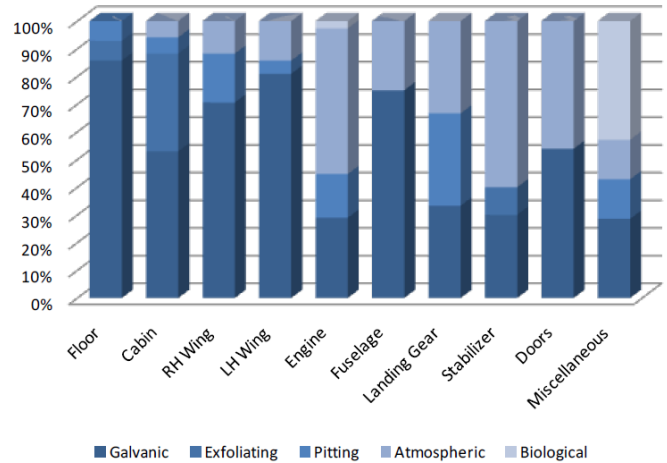
Fig. 1 Corrosion problems encountered during 8C Check

Fig. 1 shows the corrosion problems encountered during this check.

Galvanic corrosion was the most commonly observed modes of corrosion. Exfoliation corrosion was mostly noted at locations where aluminium alloys were used, with surface delamination as the most common visible damage indication. Fig. 2 shows an example of a seriously damaged part in a wing flap through exfoliation and which required

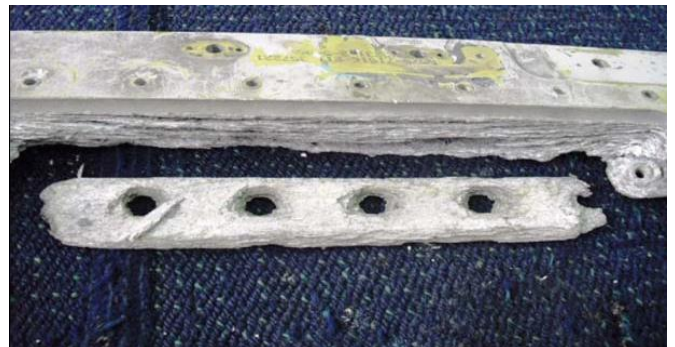
Fig. 2 Badly affected wing flap which resulted in the replacement of the part.

replacement.

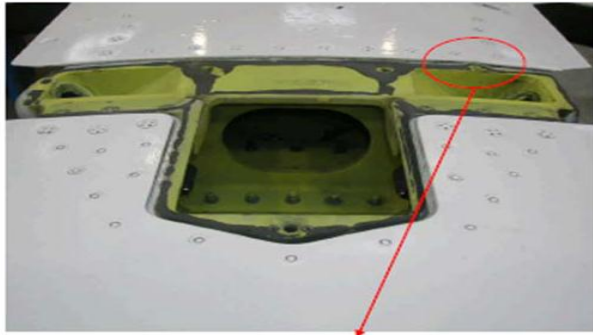
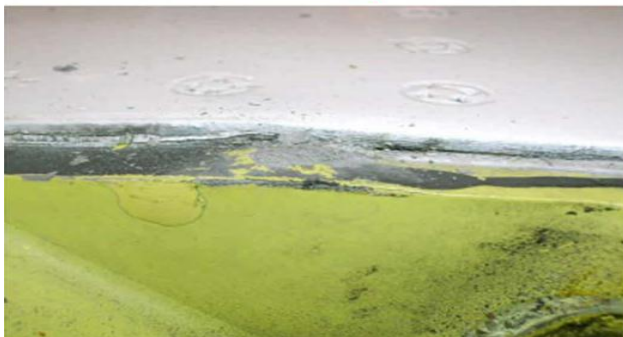
Fig. 4 Exfoliating corrosion on the fuselage

types of corrosion, namely galvanic, exfoliating and atmospheric, with galvanic corrosion as the most common one. Exfoliation corrosion was observed on the fuselage as shown in Fig. 4.

The delamination could be observed on the edge of the aircraft panel. If immediate repair was not undertaken, the corrosion would have propagated, resulting in extensive damage.

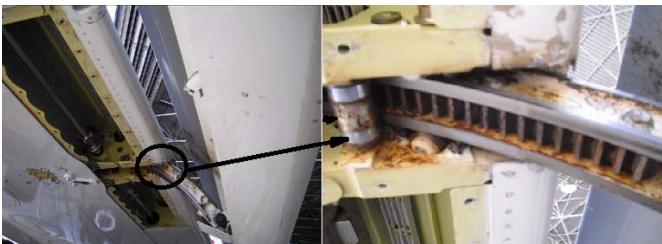
Fig. 5 Atmospheric corrosion on lower wing

Atmospheric corrosion was observed in several parts. Fig. 5 shows the effect of atmospheric corrosion in the lower wing region. Constant exposure to rainwater, moisture, high humidity and sea breeze were, most probably, some of the factors that contributed to cause corrosion in this area. Although the situation may seem alarming at first sight, the damage caused was mostly superficial rusting and well within allowable limits to ensure the aircraft airworthiness.

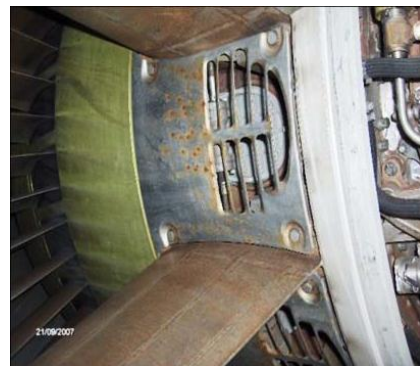
Fig. 7 Pitting corrosion on the engine

pitting corrosion observed on the engine.

The presence of very high temperatures and exhaust residues could be the prime causes for corrosion development on the engine. Although these pits were difficult to detect, their presence could have yielded in serious consequences over a long time period.

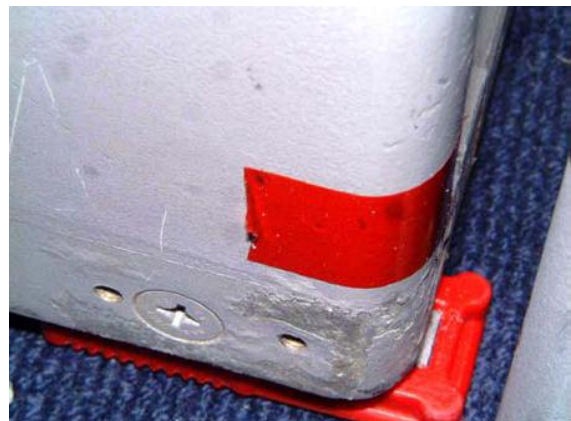
Fig. 8 Exfoliating corrosion at the base of a cabin attendant seat

There were large number of issues concerning the cabin which involved replacement of screws, nuts and fittings damaged by galvanic corrosion. Fig. 8 shows the occurrence of this type of corrosion on seat frames which were subjected to exfoliating corrosion.

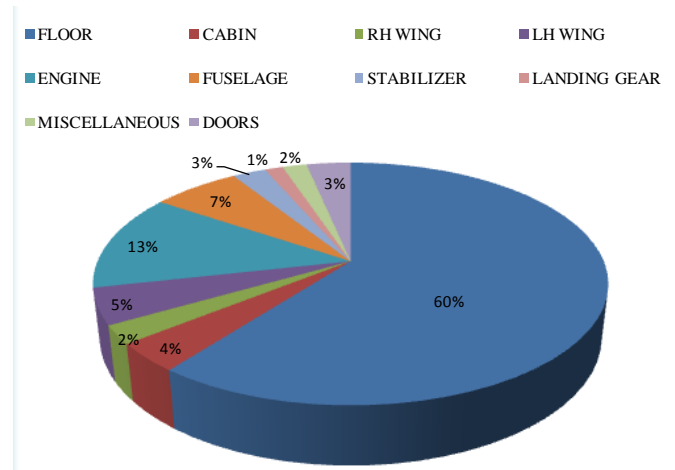
Fig. 11 Cost of corrosion for 8C Checks

For each of the three checks, the cost of corrosion was determined. For the 1C Check it was observed that 25% of the corrosion cost went to the labour cost and 75% of the cost went to replacement or reparation of the corroded materials. Figures 11 and 12 show the corrosion cost associated with the different aircraft parts for the inspections of 2004 (8C Check) and 2010 (IL2 Check) respectively.

For the 2004 check, the largest cost was associated to the floor zone due to the large number of corroded beams which had to be replaced. On the other hand the landing gear required the smallest part of the budget.

The cost of man hours for this maintenance check made up for around 40.1 % of the total cost.

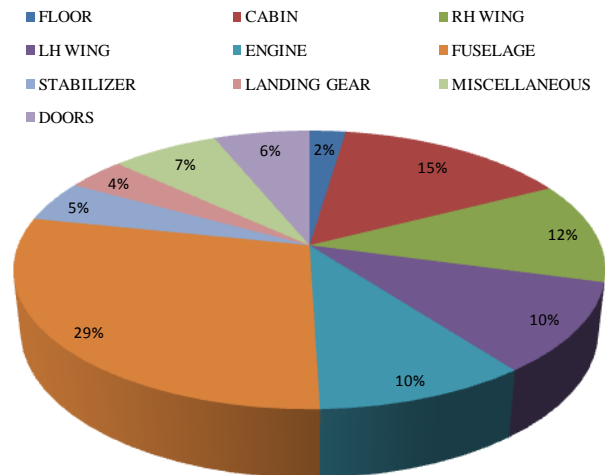
Fig. 12 Cost of corrosion for IL2 Check

As for the 2010 check, the largest sum of money was spent on the fuselage while the floor was allocated the smallest part of the corrosion budget. The cost of labour accounted for about 52.9 % of the corrosion-related budget in 2010. The small budget for the floor section is logically due to the thorough maintenance on this section in the 2004 check. The corrosive environment in Plaisance and in other airports would logically have an effect on the fuselage and on the other exposed parts and this shows out in Fig. 12.

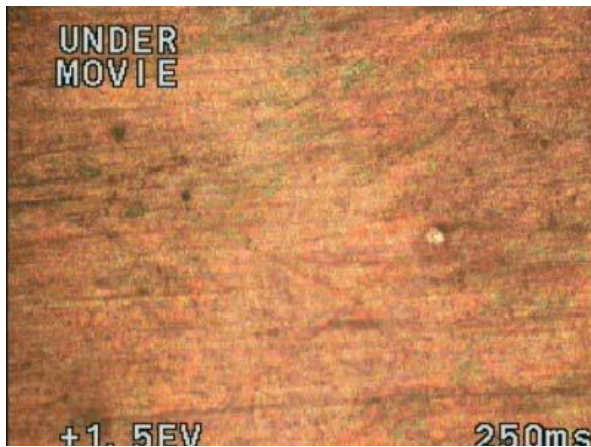
Fig. 13 Aluminium surface after 60 days immersion in sea water.

Pits were formed on the metal surface as shown in Fig. 13.
