# Regeneration Process Improvement of Demineralization Unit in LNG Plant Bontang

**Abstract**— PT Badak NGL is a world class company located in Bontang. The company is capable to produce liquefied natural gas (LNG) and liquefied petroleum gas (LPG) with the maximum capacity of 22.5 MTPA and 1 MTPA, respectively. In order to support the gas liquefaction process, PT Badak NGL operates large scale of utility plants as well.

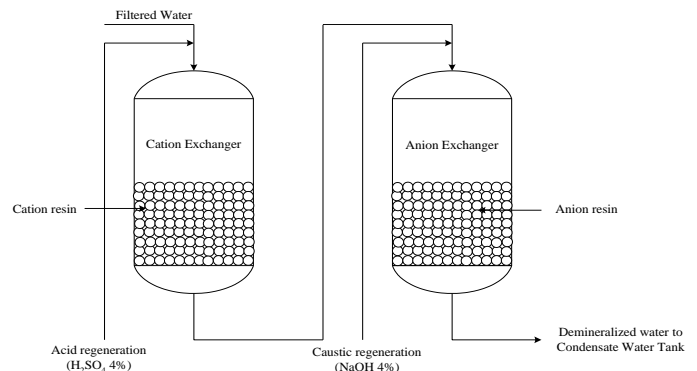
Demineralization process is mainly performed to remove all mineral and salts contained in the filtered water after aeration and filtration process. There are two ion exchange vessels which each of it is utilized by passing the water through the ion exchange resin. By using the Cation and Anion Exchanger, all the ions are exchanged with the cation and anion resin to be demineralized water. The simplified scheme of Demineralization Unit can be seen in Figure 1 as follow:

Fig.1. Ion Exchange System in Demineralization Unit

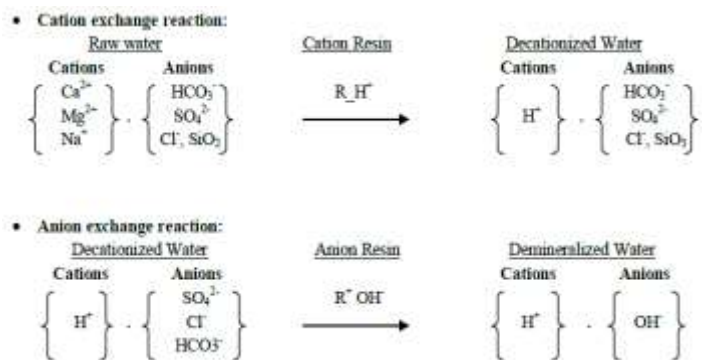
The cation and anion exchange reactions can be seen as follow:

Fig.2. Cation and Anion Exchange Reactions

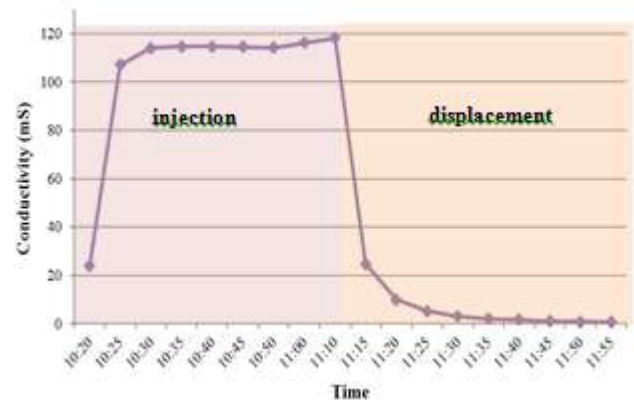
Fig.3. Regenerant Curve for Cation Regeneration

Based on Figure 3 above, total acid injected to Cation Exchanger was considered good enough. It was shown by the flat figure at the end of injection step which occurred as long as 50 minutes. But for the acid displacement step which was normally performed for 30 minutes, it was considered not enough. The total ions contained in the decationized water still decreased till more than 45 minutes. It can be conclude that the improvement should be done especially for acid displacement step in the Cation Exchanger. All regenerants were considered wasted after more than 45 minutes of acid displacement. In order to optimize the regenerants wasted from the Cation Exchanger, the acid displacement step was then extended from 30 minutes to 1 hour.

Elution study of Demineralization E was conducted in both Cation and Anion Exchangers. The figure of acid and caustic injection to Cation Exchanger and Anion Exchanger can be seen in Figure 3 and 4 as follows:

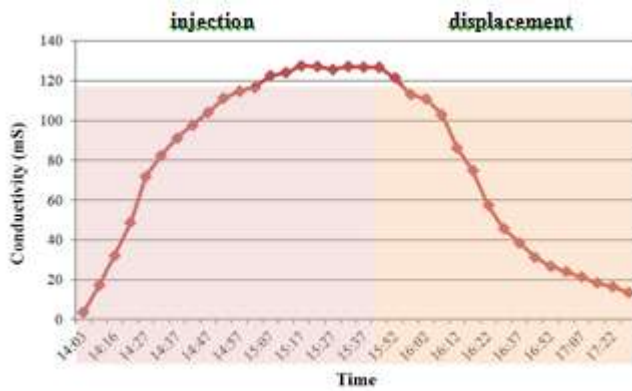
Fig.4. Regenerant Curve for Anion Regeneration

Based on Figure 4 above, the total caustic injected to the Anion Exchanger was considered good. For caustic injections, the total chemical injected to the vessel was sufficient to absorb all the ions in the vessel (shown by the flat figure at the end of injection step). But for the displacement step, it needed an improvement to prolong the duration of caustic displacement step. In the Anion Exchanger, the caustic displacement step that normally occurred for 1 hour was not enough to relieve the residual regenerant left in the vessel. Refer to the result of this performance test, the duration of caustic displacement step should be extended to 2 hours.

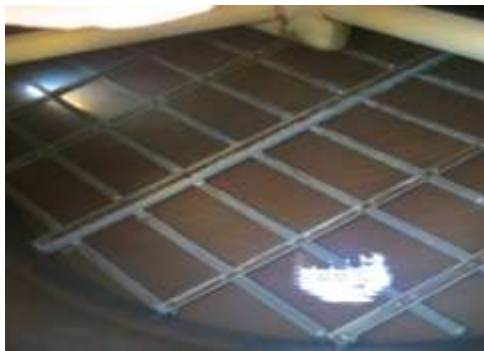
Fig.5. Bed's Condition of Cation Exchanger

- The condition of Cation Exchanger's bed was considered good enough. But there was an indication of resin's mal-distribution in the Anion Exchanger that was possible caused by the broken or damaged lateral distributors. The internal inspection was then conducted especially in Anion Exchanger due to that finding. 13 of 20 lateral distributors at the middle of the Anion Exchanger for injection were found torn.

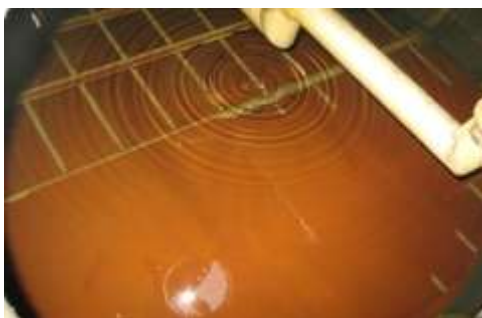
Fig.6. Bed's Condition of Anion Exchanger

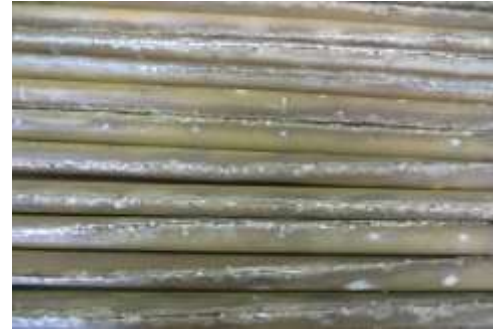
Fig.7. Lateral Distributors Condition

- No defect or damage was found on the bottom lateral distributors (Johnson strainer).

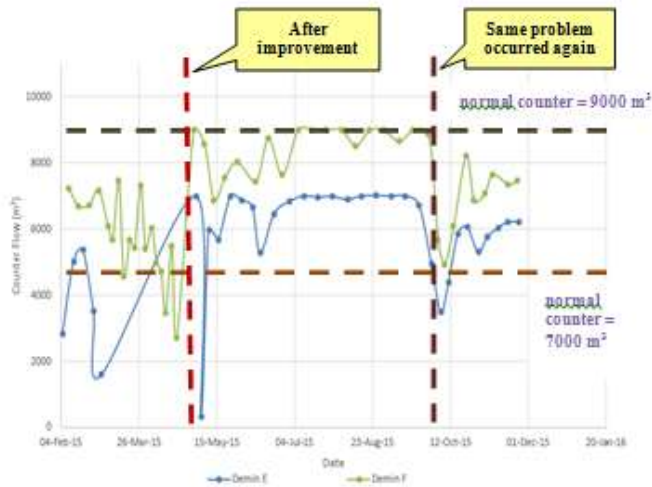
Fig.8. Trending of Demineralization Unit's Performance

Based on the performance trends of Demineralization E and F on Figure 8 above, both of Demineralization E and F couldn't constantly achieve the normal counter flow of 7000 and 9000  $m^3$ . Based on the plant observation, there was no any problem with the unit and the whole control valves installed in the Demineralization Unit. This condition was considered caused by the quality of the ion exchange resin itself. Due to resin aging, performance of Demineralization Unit is also changed. Inorganic and organic fouling still happen despite tight pre-treatment control is performed. This fouling causes chemical displacement more difficult than before. On the other side, another problem is about the service rinse step. Service rinse step after fast rinse still consumed a lot of time which also reduced the service counter of Demineralization Unit itself. The service rinse period takes 8-12 hours for each Demineralization Unit before putting it in service mode.

from design procedure of 45 minutes. Based on the operational condition, this improvement was considered not enough to get the best performance of Demineralization Unit. The problem of silica premature breakthrough occurred again in the mid of September 2015 so the Demineralization Unit couldn't achieve the normal setting counter again. The figure of Demineralization Unit's performance can be seen in Figure 8 as follow:

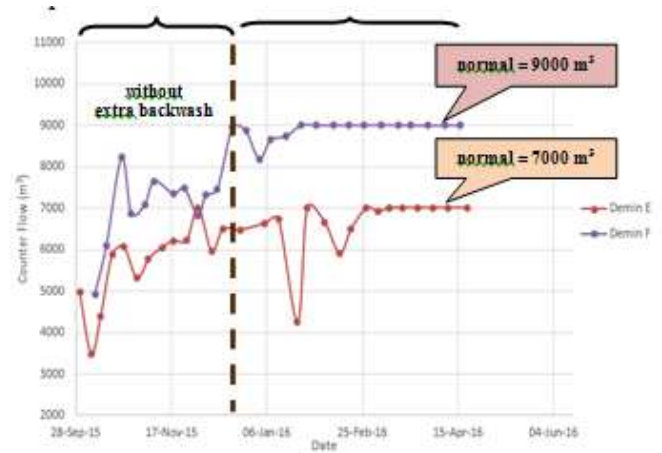
Fig.9. Trending of Demineralization's Counter Flow

Based on the plant observation which is also shown on Figure 9 above, the service counter of Demineralization Unit with the extra backwash step is evenly better and meets the normal setting counter of 7000 and 9000  $m^3$ . Extra backwash is conducted after fast rinse step in Cation Exchanger Unit, with the flow rate of 90  $m^3/hr$  rate and 10 minutes time's duration. This additional sequence can practically reduce service rinse period which the water is recycled to Filtered Water Tank. Service rinse is performed until the electrolyte conductivity achieves the specification of maximum limit 5  $\mu mhos/cm$ . Before conducting the extra backwash step, it takes 8 - 12 hours for service rinse step, which means it has already used 720 – 1080  $m^3$  of service counter in Demineralization Unit.

In order to compromise with present resin condition and performance of Demineralization Unit, the modification of regeneration process should be conducted. The proposed improvement is to reduce service rinse duration is by conducting extra backwash at Cation Exchanger in the step after fast rinse sequence. The plant observation of adding extra backwash step was started since December 2015. Based on actual plant test, the service counter of Demineralization Unit tends to be longer if the extra backwash is performed. The comparison of Demineralization E and F service counter's either by implementing the extra backwash step or not can be seen in Figure 9 as follow:

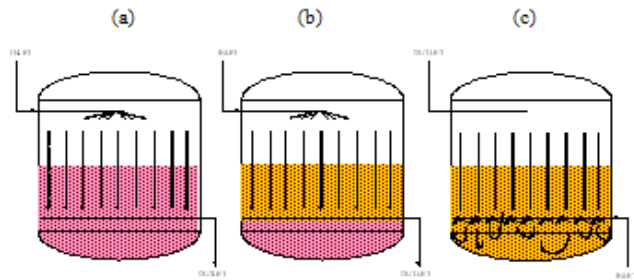
This extra backwash program which is put at the end of regeneration sequence is considered strongly fit out the rinse step by removing the remaining sulphuric acid which attached at lower resin bed. The simplified diagram of remaining sulphuric acid in resin bed can be seen at Figure 10 below:

Fig.10. Bed Condition After Acid Injection (a); Displacement-Rinse (b); Extra Backwash (c)

During acid displacement and rinse, resin's bed becomes compacted. It is caused by pressure of downward flow. As a compact bed, the remaining chemicals attached at resin's surface will be harder to be stripped out. For new or less fouled resin, the remaining sulphuric acid can be easily removed throughout this downward flow, but for fouled resin, the removal process will be harder. With this improvement, by adding extra backwash step, it pushes the resin bed from bottom of the vessel to expand and strip out the remaining sulphate ion especially where attached at below of lateral distributor. By reducing sulphate content of outlet cation vessel, anion resin load will be reduced. Less anion exchange load tends longer anion exchanger service counter. Water treated quantity should be maximized in order to reduce regeneration frequency which means less chemical consumption and reduce waste water to environment.
