# Development of Damage Rate and Damage Index Functions for Brick-nogging and Wooden Buildings in 2012 Thabeikkyin Earthquake

Nan Pawt Sai Awar, Dr. Kyaw Moe Aung

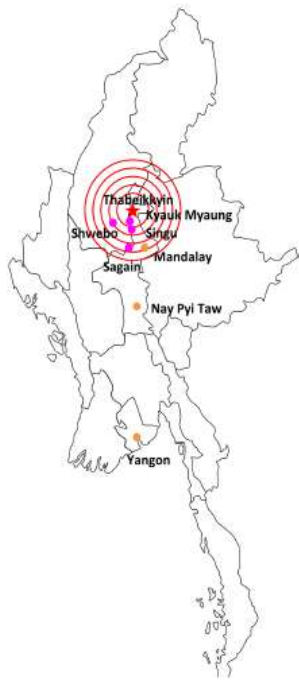
Fig.1 Location of epicenter and main affected areas of the earthquake

During field survey, the structural types of buildings were classified as R.C, brick-nogging, masonry and wooden buildings. We made preliminary field survey on 29 May and 11 June with some master students from Department of Civil Engineering, Mandalay Technological University in 2014. During this survey, we made visit to the General Administrative Office in the Thabeikkyin Township and collected the recorded photographs and the damage statistics data such as the numbers of buildings that partially collapsed and totally damaged in this township. Fig. 1 and Fig.2 show the location of epicenter and intensity of earthquake affected areas.

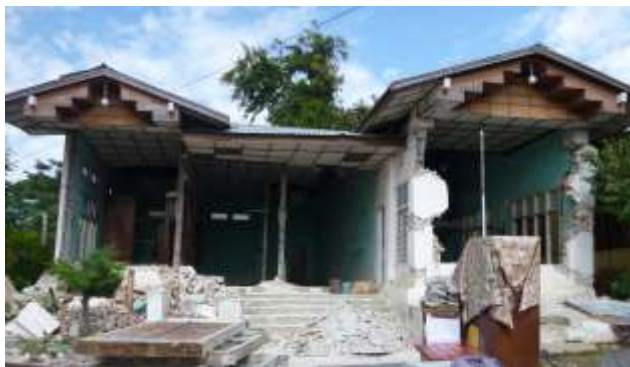
Fig. 3 Collapse of masonry walls in single-storey governmental office

According to the preliminary investigation and recorded photographs, it can be seen that the most damaged structural type of building was brick-nogging (wooden frame with brick walls). Wooden building was the second most damaged structural type. Other structural types of buildings such as R.C buildings and masonry buildings also damaged but they are not so much in number compared with brick-nogging and wooden. They can also be classified as residential buildings and non-residential buildings such as governmental offices, hospital (including dispensaries), school and religious buildings by the usage of buildings. Fig.3, Fig.4 and Fig. 5 show some damage buildings after Thabeikkyin Earthquake.

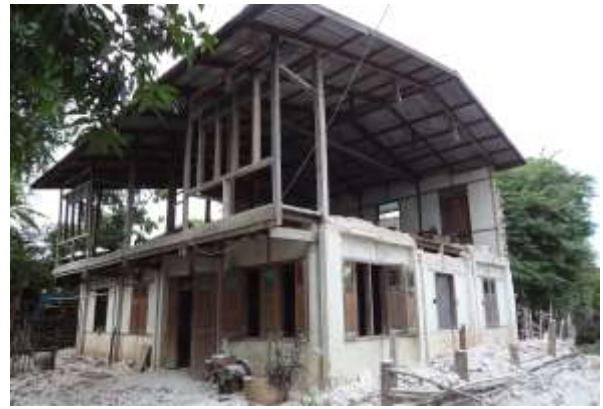
Fig.4 Collapse of masonry walls in two-storied residential building

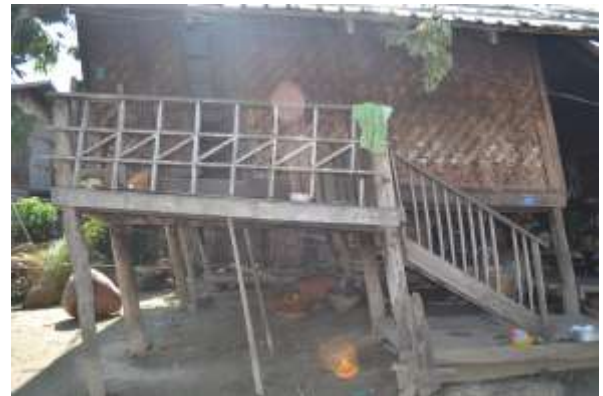
Fig. 5 Failure of veranda in wooden residential building

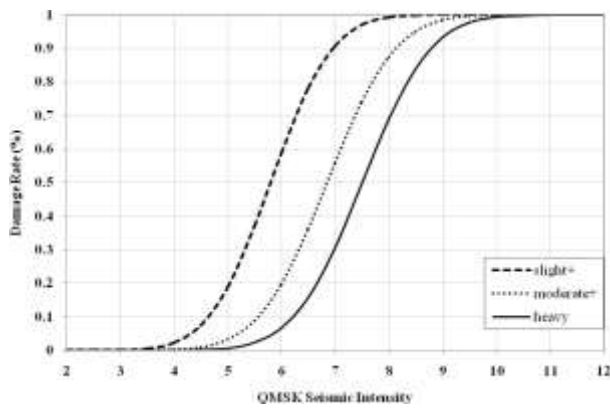
The curves of the damage rate functions of brick-nogging buildings and wooden buildings are constructed using the damage ratio of buildings in each location and the estimated MSK seismic intensity by questionnaire survey. The function is generally described with the following cumulative normal distribution function.

where,  $F(x)$  means damage rate in damaged area,  $\phi$  is the standard normal distribution and  $\mu$  and  $\sigma$  are the mean and standard deviation of  $x$ . The two parameters of the distributions,  $\mu$  and  $\sigma$  are determined by the least square method on normal probability plotting paper.

Fig. 7 Damage rate function of wooden buildings

Fig. 6 and Fig. 7 show the damage rate curves for brick-nogging buildings and wooden buildings.

Damage Grades	For Brick-nogging		For Wooden	
	Average ( $\mu$ )	Stand. Dev. ( $\sigma$ )	Average ( $\mu$ )	Stand. Dev. ( $\sigma$ )
Heavy	7.6	0.72	7.5	1.0
Moderate+	6.6	0.8	6.85	1.0
Slight+	5.45	0.8	5.8	0.9

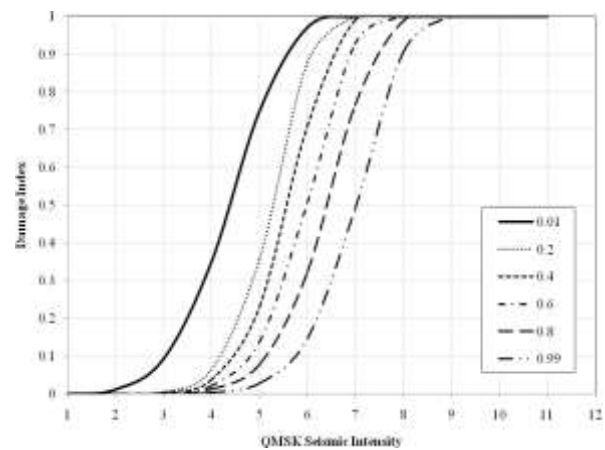
rate function [7]. The seismic intensity affecting the damage grades can be obtained at arbitrary damage rates (1%, 20%, 40%, 60%, 80% and 99%) in this study. The damage index functions are obtained by fitting the following cumulative probability distribution with the Weibull density function.

where,  $F(x)$  means damage index,  $x$  is an index of seismic intensity,  $\beta$  and  $\eta$  are parameters of the Weibull distribution. These two parameters of the distribution are determined by Weibull distribution plotting paper.

Fig. 8 Damage index function of brick-nogging buildings

Table VI describe the parameters of damage index function for brick-nogging buildings and wooden buildings. Fig. 8 and Fig. 9 show the damage index functions of brick-nogging buildings and wooden buildings.

for brick-nogging buildings						
Damage rate (%)	0.01	0.2	0.4	0.6	0.8	0.99
$\eta$	4.7	5.5	5.85	6.25	6.7	7.3
$\beta$	5.22	8.5	8.5	8.5	8.5	9.4
for wooden buildings						
Damage rate (%)	0.01	0.2	0.4	0.6	0.8	0.99
$\eta$	4.9	6.8	7.6	8.1	9.1	11
$\beta$	5.53	5.53	5.53	5.875	5.53	5.875

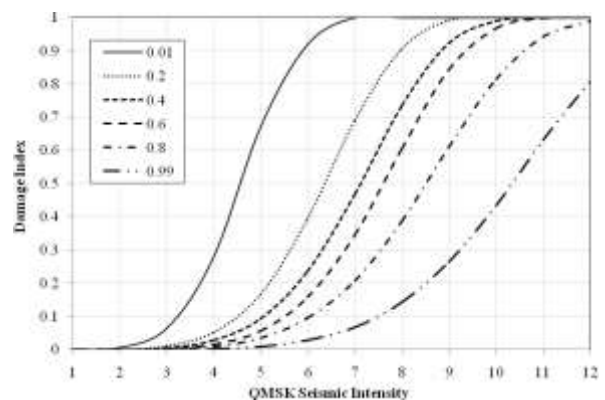
Fig. 9 Damage index function of wooden buildings
